M:\Alameda County PWA\AL_12102-Patterson Pass Road_PSP\CAD\1\Exhibits\Patterson Pass Exhibit_Accident_Spot Data_Sheet_TIFF.dwg 1/28/2014 8:04:24 AM PST

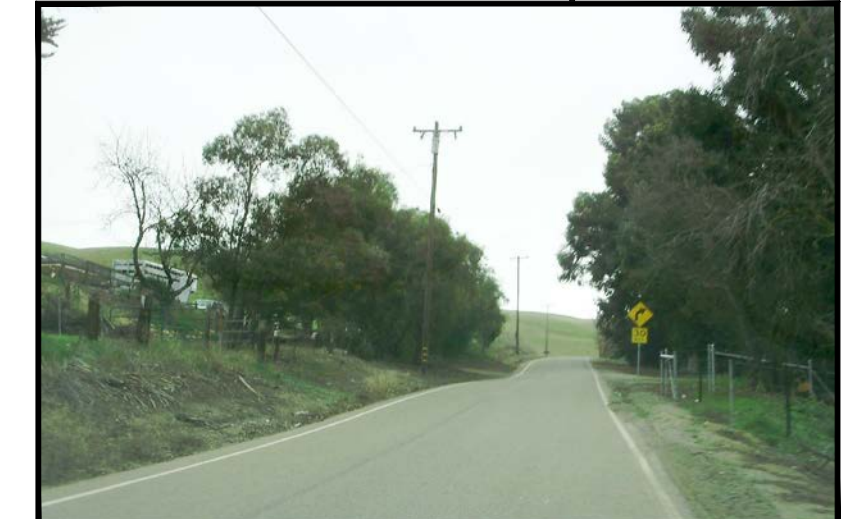
LOOKING EAST

(EXISTING "DO NOT PASS" SIGN TO BE EQUIPPED WITH HIGH INTENSITY FLASHING LED LIGHTS)
